# **San Jacinto River Waste Pits Superfund Site**

# San Jacinto River Waste Pits Draft Feasibility Study

## **San Jacinto River Waste Pits Update on Armor Cap**

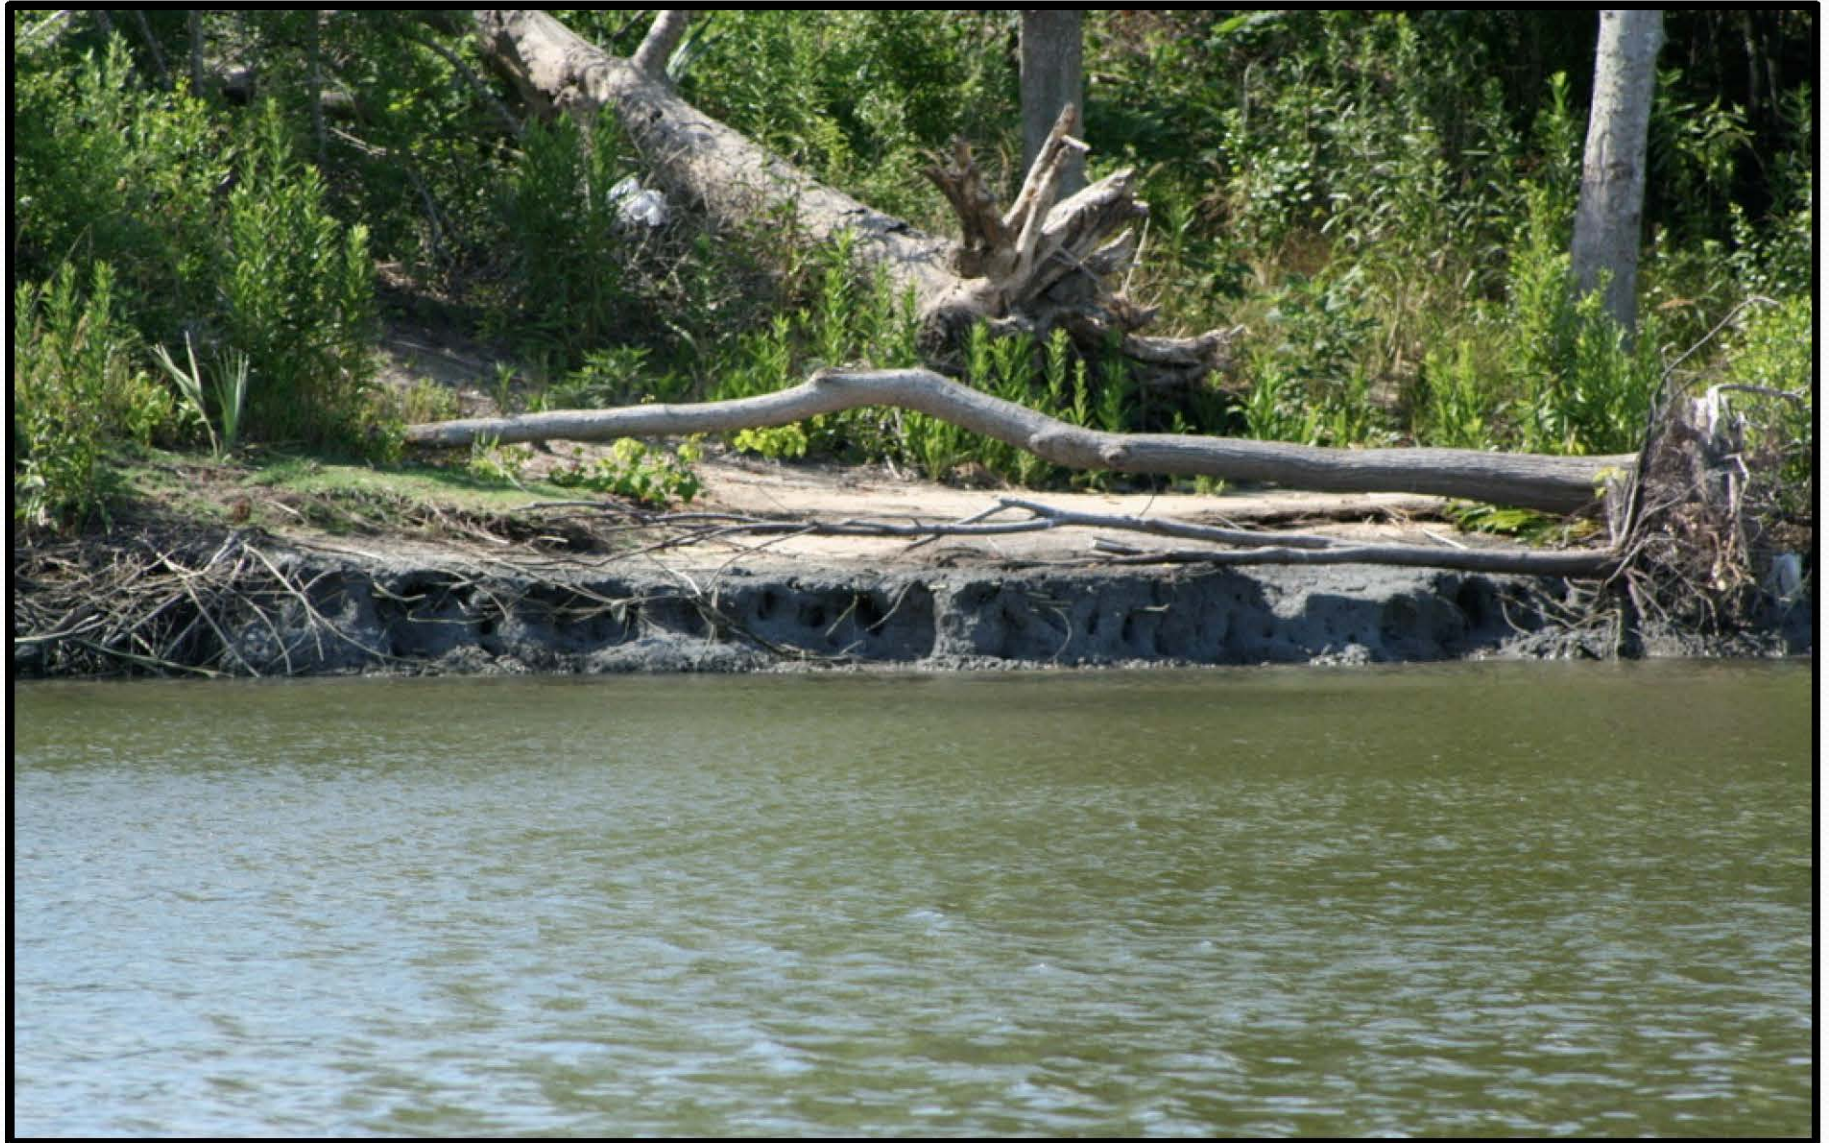
# Northern Waste Pits Before Cap

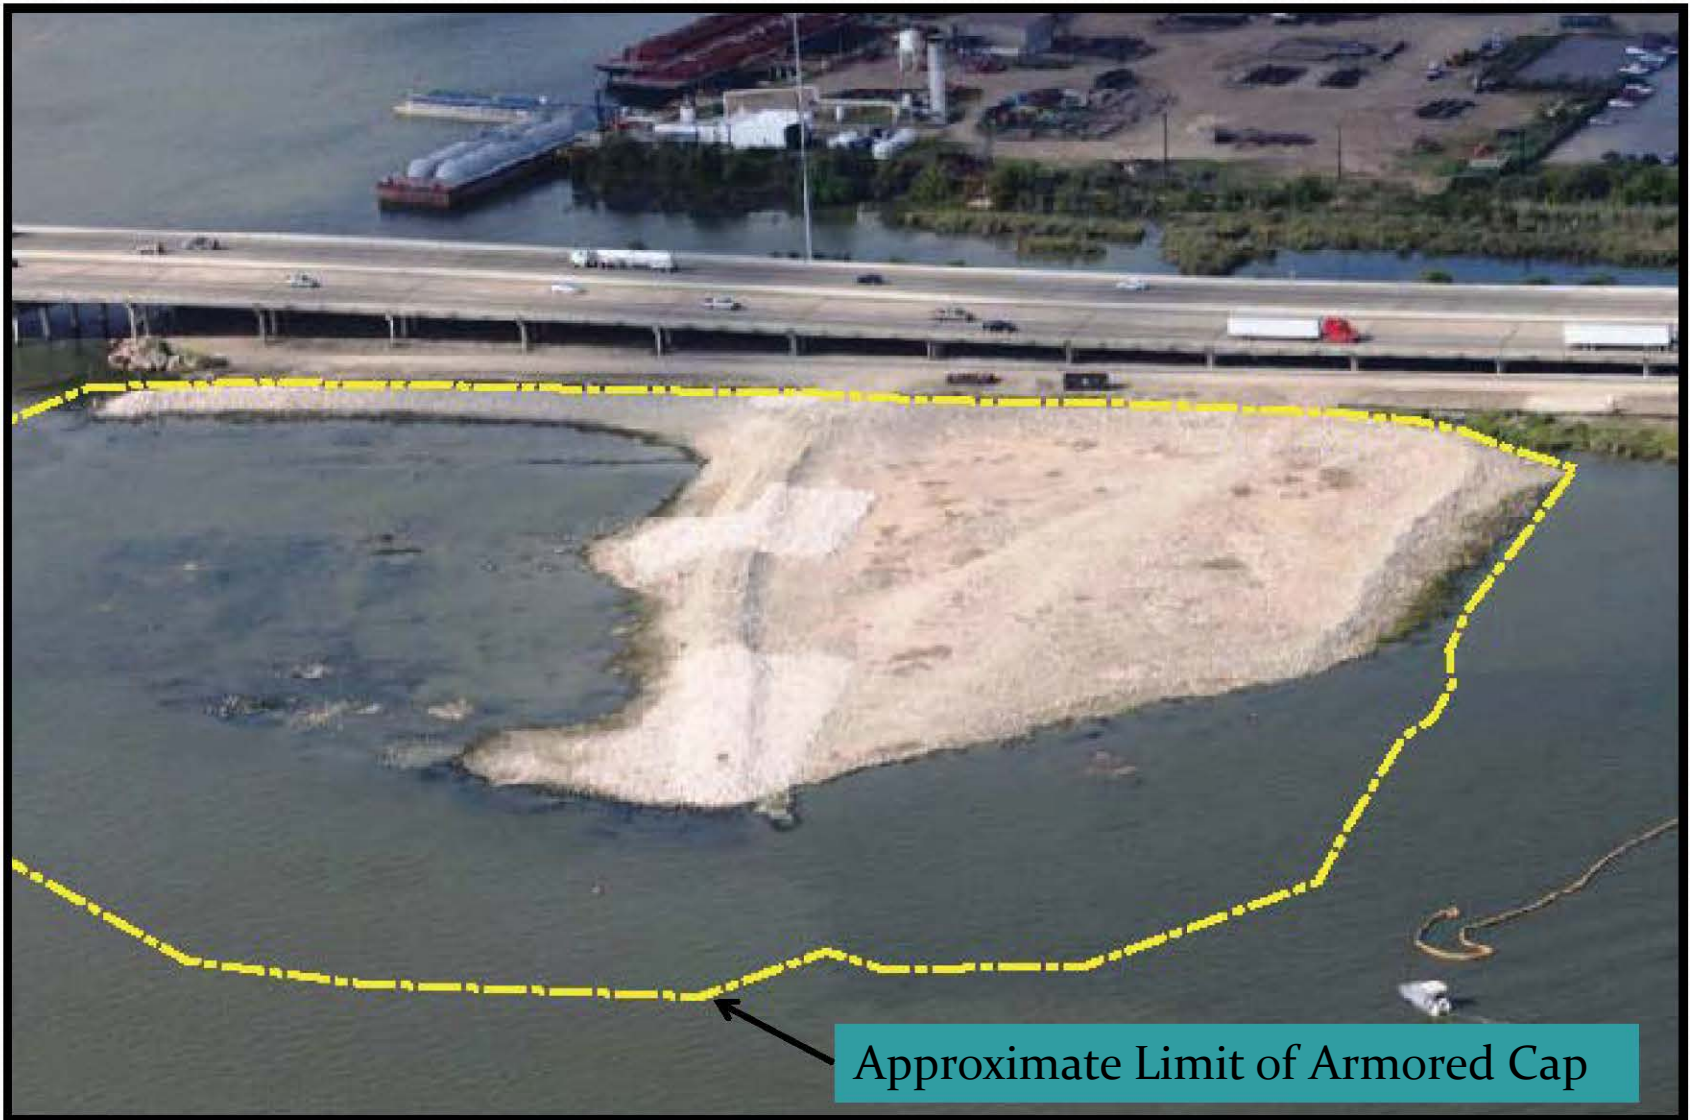
# North Waste Pits After Cap

Approximate Limit of Armored Cap

**Cap Construction Completed July 12, 2011**

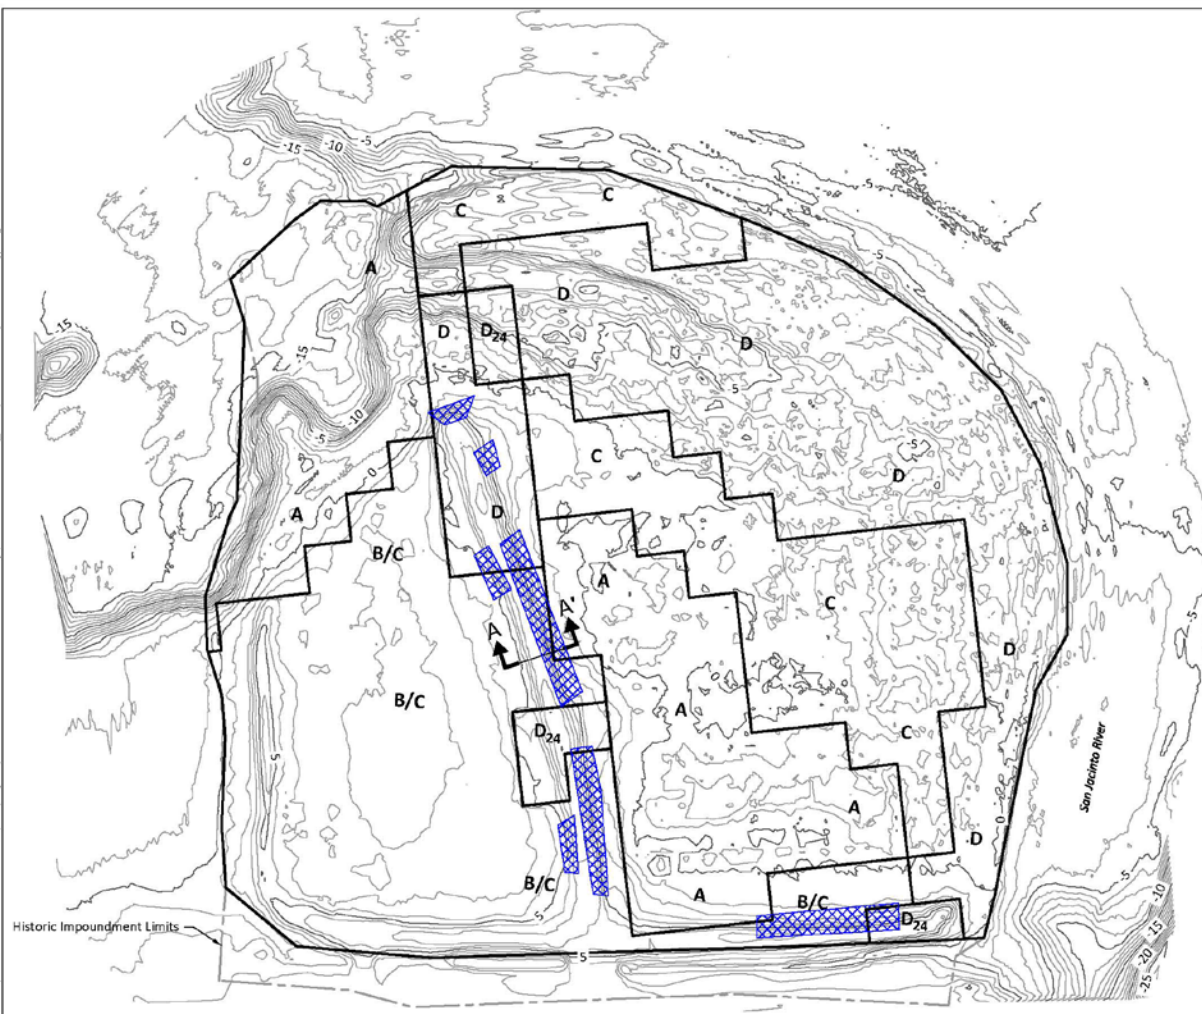
**Figure 1**  
Armor Cap Repair Plan  
San Jacinto River Waste Pits Superfund Site

- Existing Contour (1 Foot Interval)
- Armored Cap Type and Boundary
- Historic Impoundment Limits
- Areas of Additional Armor Cap D Rock Placement
- Cross Section Location and Designation

**Fig. 1 – Armor Cap Enhancement Work Plan - Armor cap D placement areas with improved slope construction**

- TCRA cap erosion repaired in August 2012. The US Army Corps of Engineers reviewed the cap design and construction and determined that there are deficiencies (including slope and grading of cap materials).
- On November 1, 2013, EPA notified the Potentially Responsible Parties to address the TCRA cap design and construction protectiveness issues until the final Site remedy is selected.
- PRPs submitted armor cap “Enhancement” work plan on 11/27/13, and EPA approved plan on 01/10/14.
- Construction repairs on armor cap begin on 01/17/2014

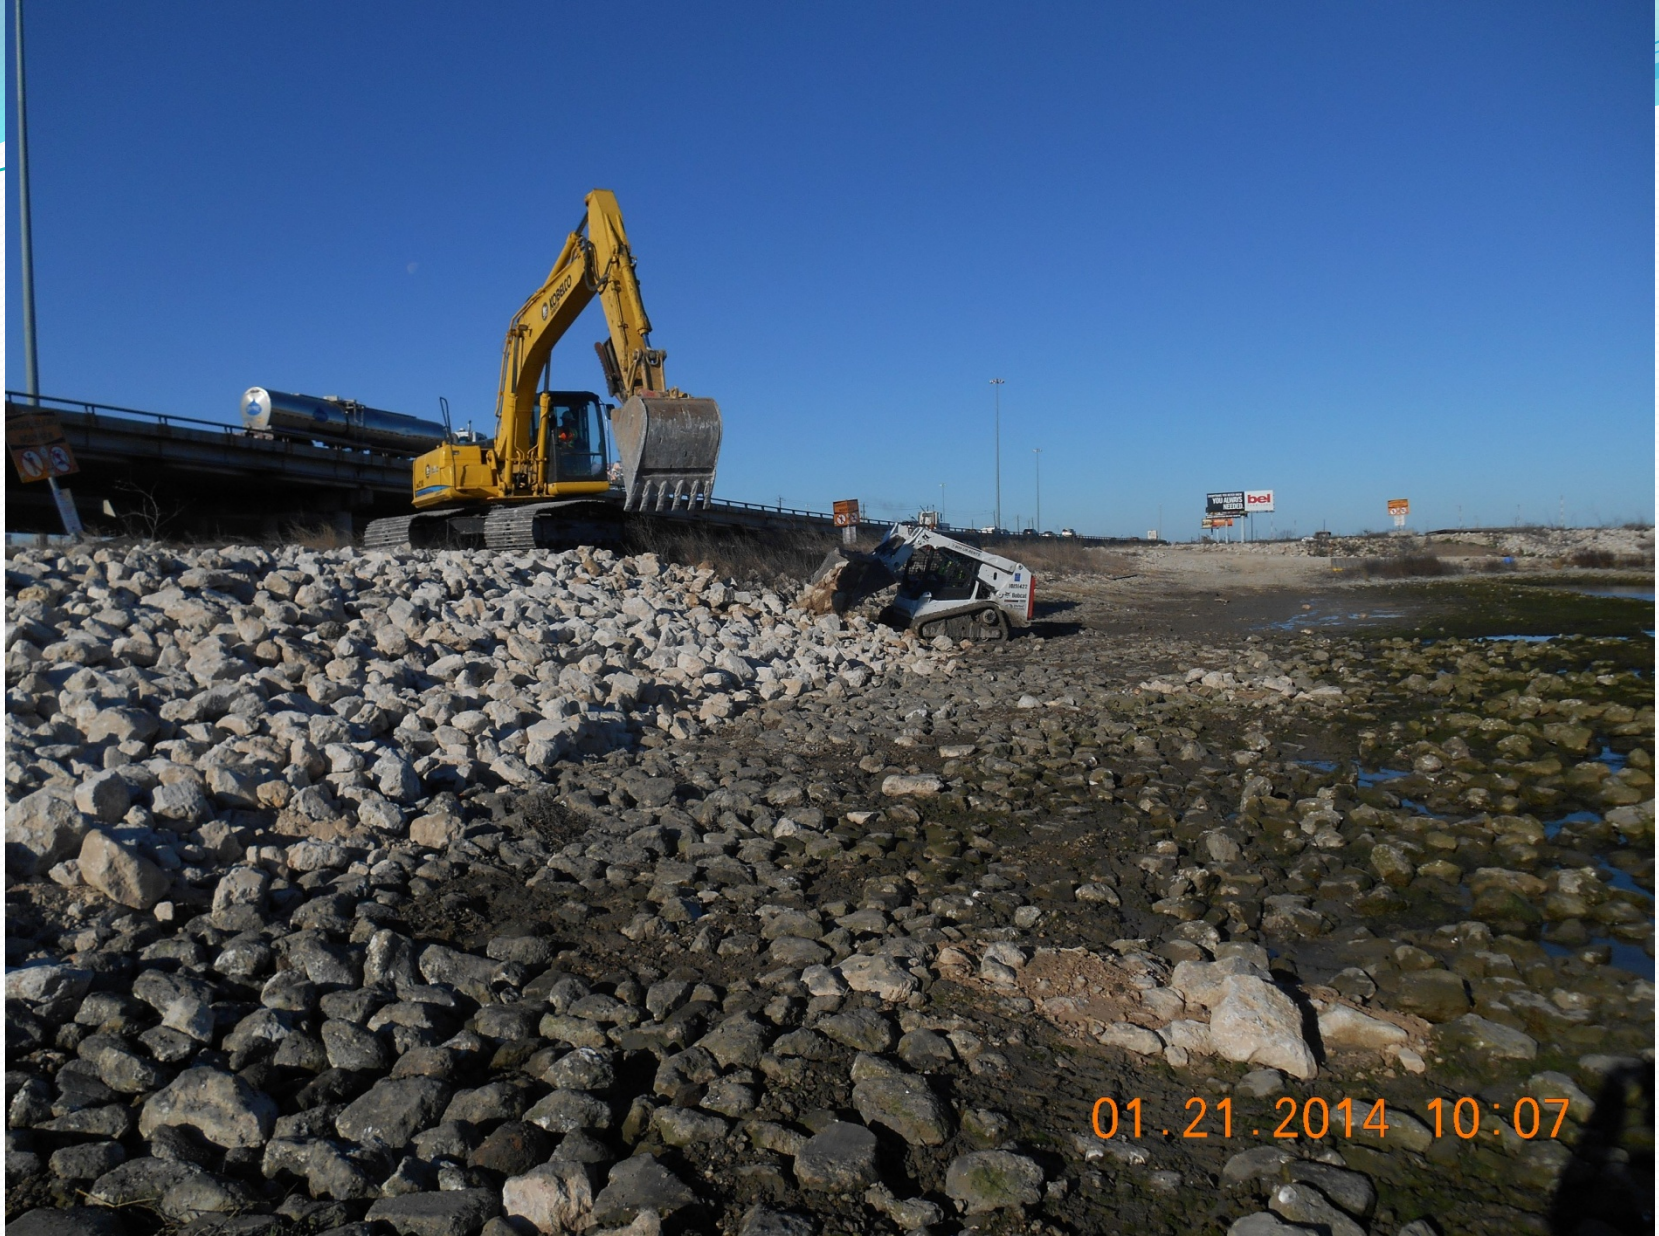
**Constructing enhanced slope along the South Berm in the Eastern Cell using an excavator (for grading the rock) and skid steer (for transporting rock from the stockpile and placing it)– 1-21-2014**

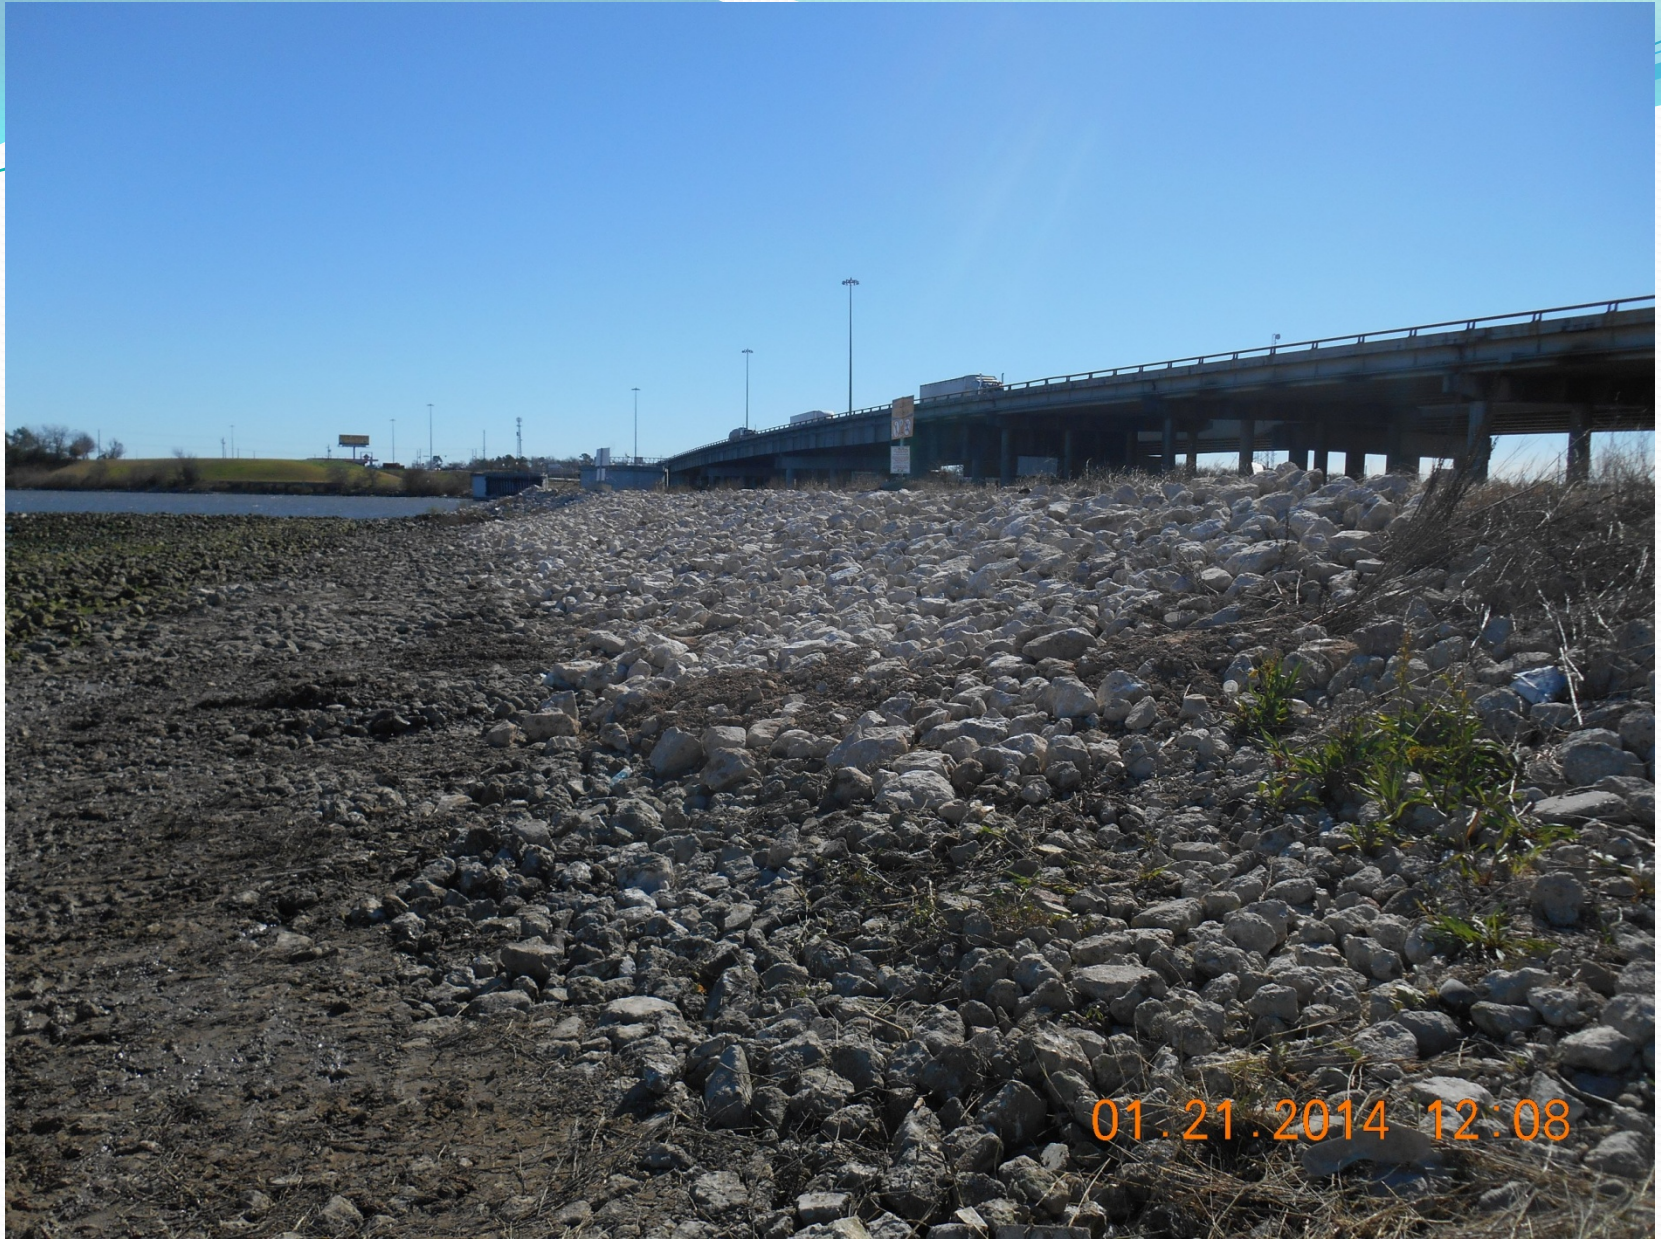
**South Berm in the Eastern Cell after completion of the enhancement work  
-1-21-2014**

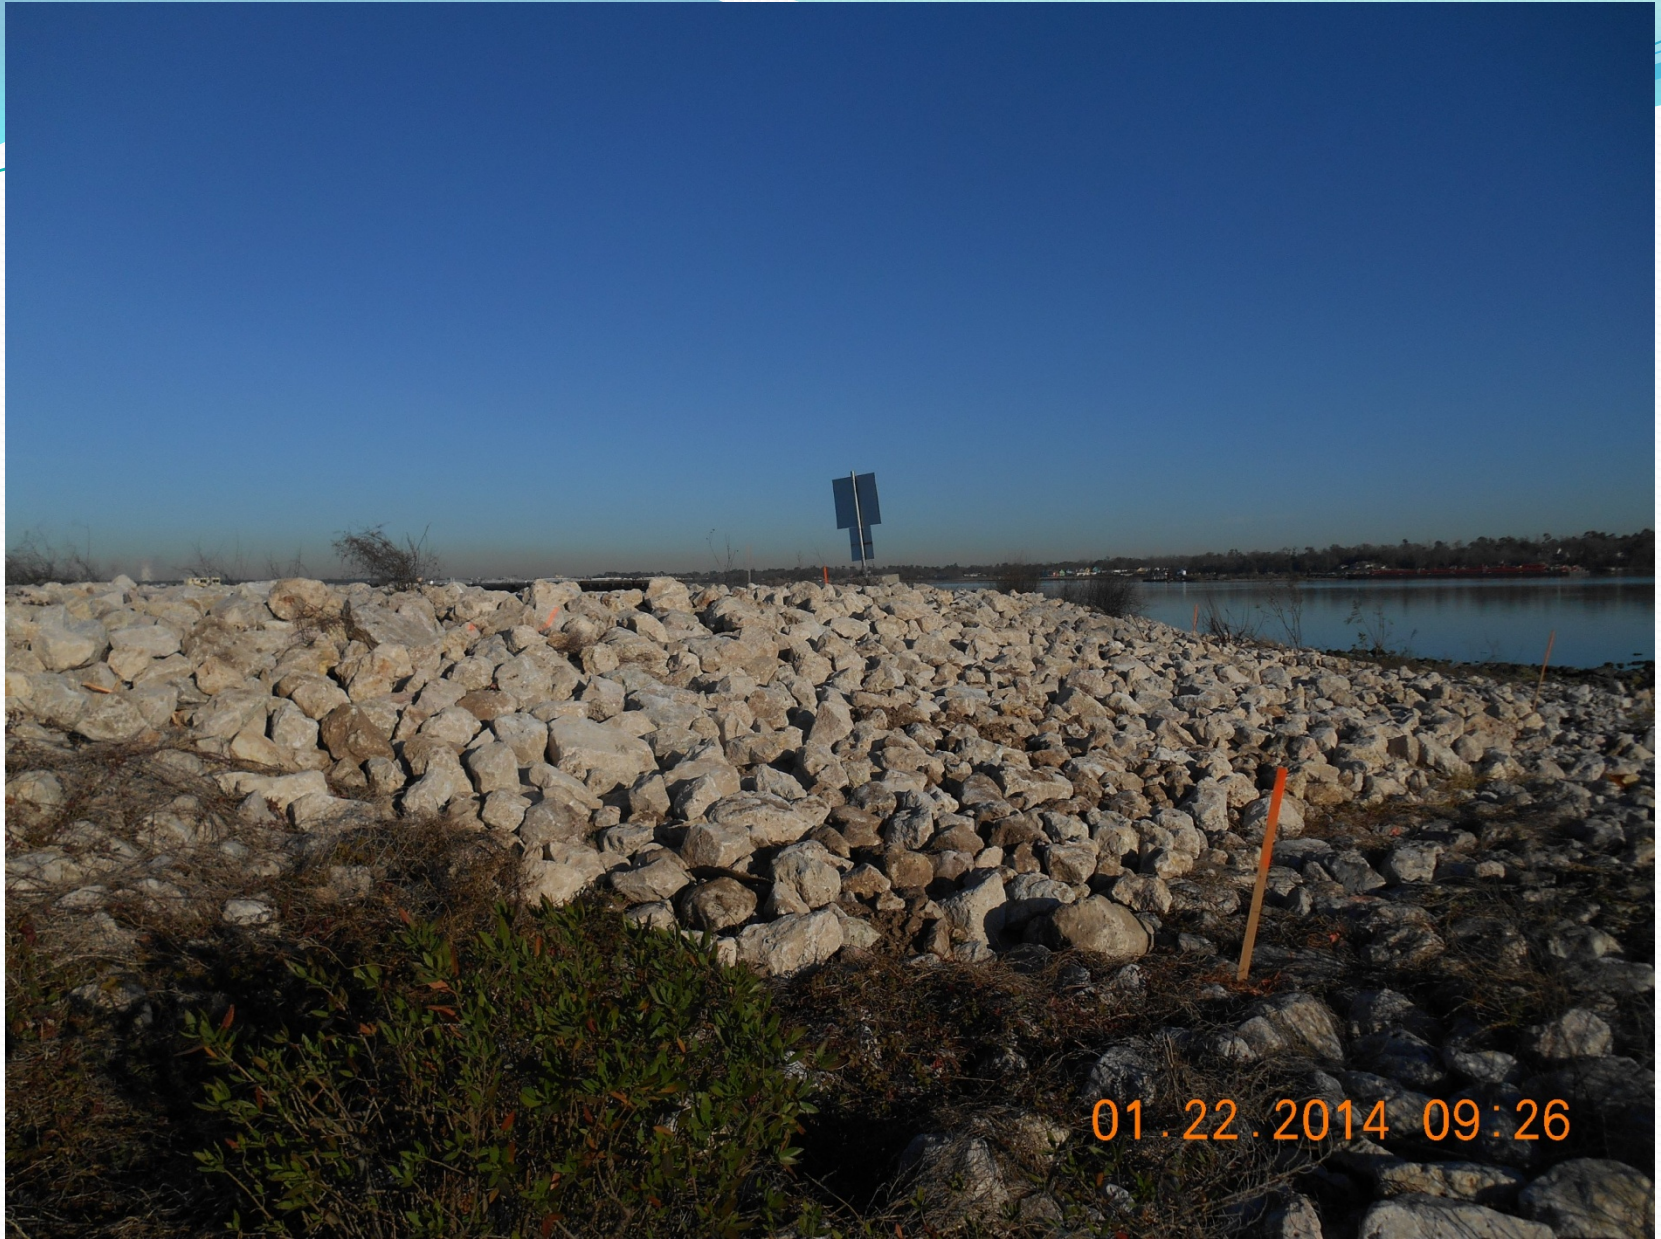
**Central Berm on the eastern slope, near the north end of the berm, after completion of the enhancement work 1-22-2014**
